Figure 2b (FER-213). Surficial features along the trend of the Javon Canyon fault.

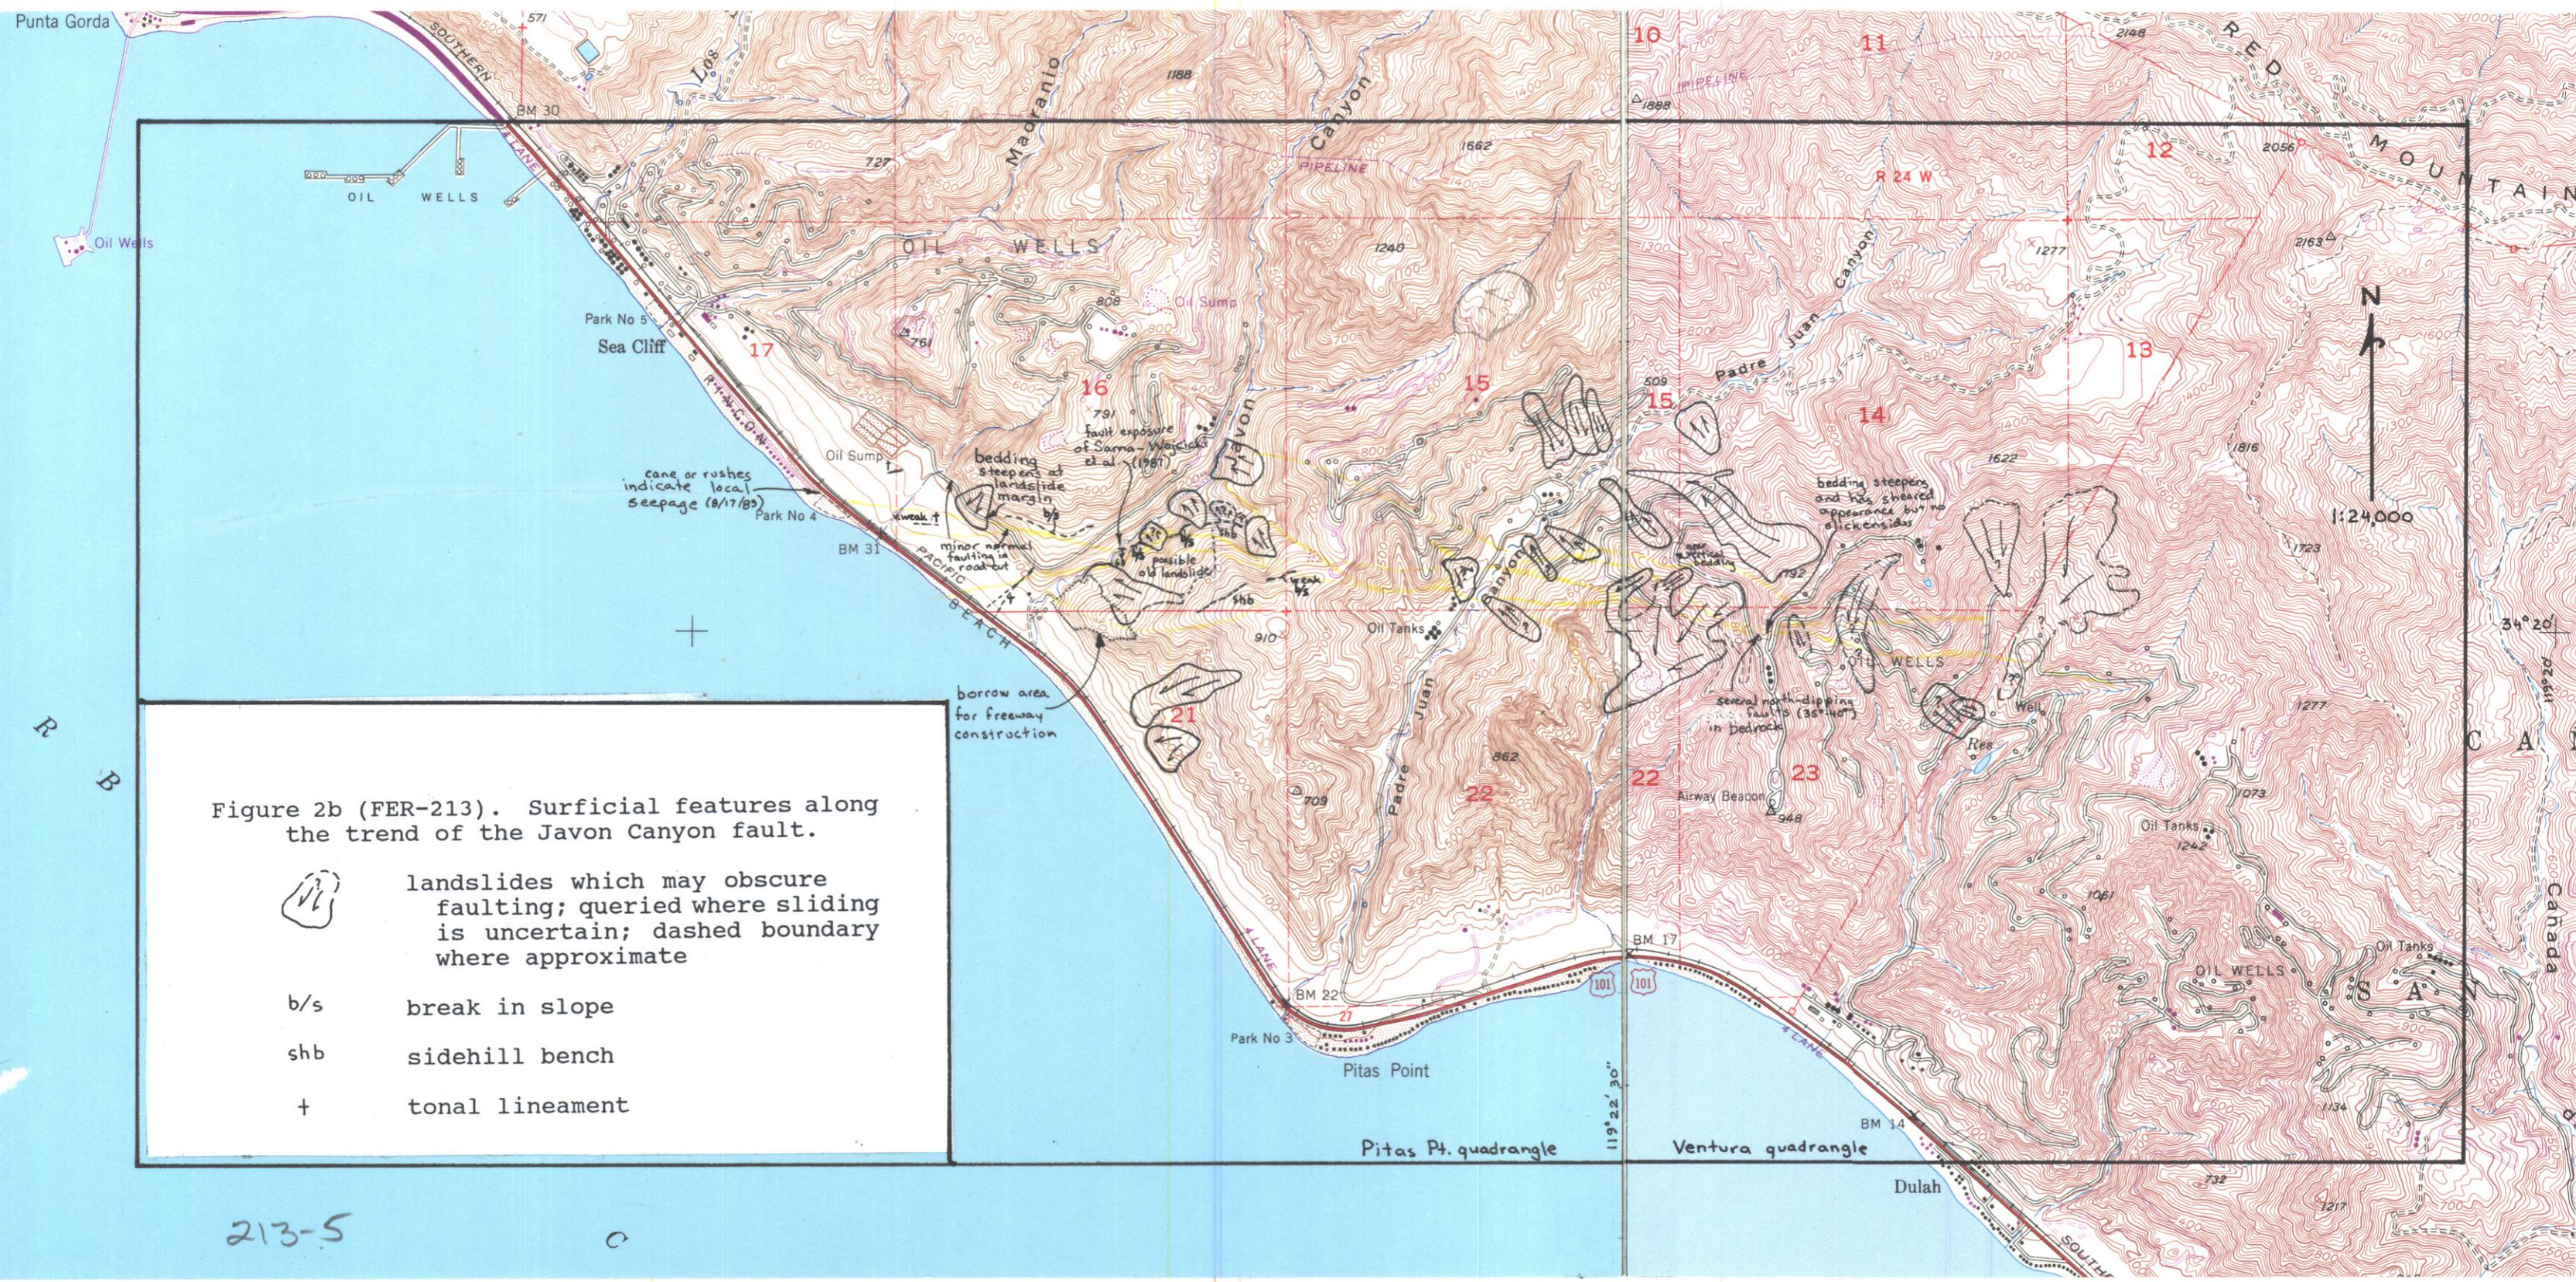
landslides which may obscure faulting; queried where sliding is uncertain; dashed boundary where approximate
- b/s break in slope
- shb sidehill bench
- + tonal lineament
